Hiller Highlands I Association

Spyglass Hill & Hiller Road Oakland, California 94618 December 3, 2020

Prepared by: D.L. "Dan" Huntley, RS Tamarra "Tammy" Axton, PRA Ray Axton, PRA

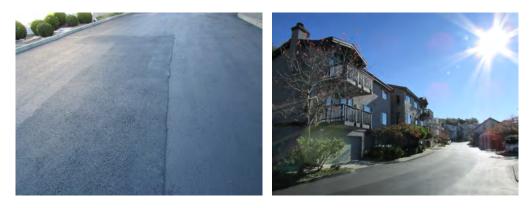
Asphalt: Repairs		33,570 SF	@ \$6.72
Asset ID	1003	Asset Actual Cost	\$11,279.52
Group	Capital	Percent Replacement	5%
Category	Asphalt	Future Cost	\$11,685.58
Placed in Service	July 2017		
Useful Life	5		
Replacement Year	2022		
Remaining Life	1

This component is the repairs to the asphalt surface in conjunction with the application of sealcoat (5 years).

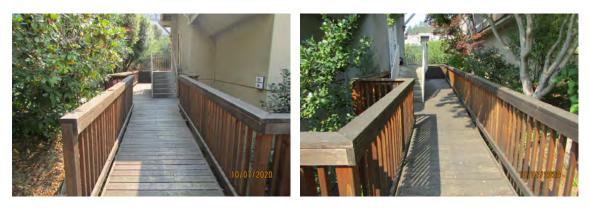
Decks: Wood-Replace-B	uildings D1 & D2	1,786 SF	@ \$18.66
Asset ID	1028	Asset Actual Cost	\$33,326.76
Group	Capital	Percent Replacement	100%
Category	Decks	Future Cost	\$58,687.98
Placed in Service	October 2017		
Useful Life	20		
Replacement Year	2037		
Remaining Life	16

This component is the replacement of the wood deck, railings and stairs located in front of the upper units of buildings D1 and D2.

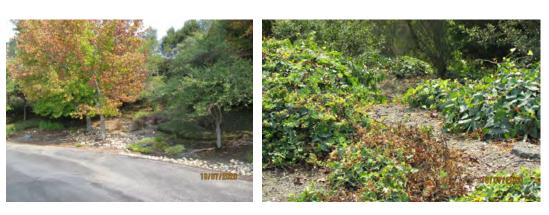
Landscape: Improvements-Fire Suppression

This component is the work required in the landscape area to aid in the suppression of fire.

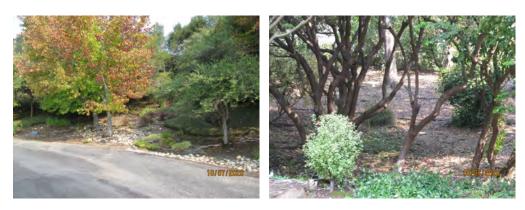
Landscape: Tree Reno	vation	1 Total	@ \$10,000.00
Asset ID	1074	Asset Actual Cost	\$10,000.00
Group	Capital	Percent Replacement	100%
Category	Landscaping	Future Cost	\$13,270.22
Placed in Service	July 2019		
Useful Life	10		
Replacement Year	2029		
Remaining Life	8

This component is the work required on tree renovation as needed.

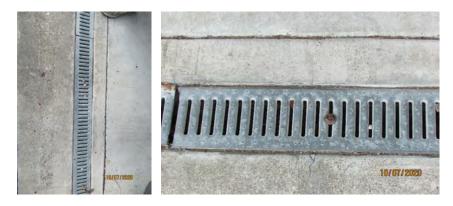
Lateral Drain: Repla	ace/Repairs	1 Total	@ \$14,068.19
Asset ID	1040	Asset Actual Cost	\$1,406.82
Group	Capital	Percent Replacement	10%
Category	Grounds Components	Future Cost	\$1,564.29
Placed in Service	October 2019		
Useful Life	5		
Replacement Year	2024		
Remaining Life	3

This component is an allowance for the repair, maintenance or replacement of the lateral drains in the common area.

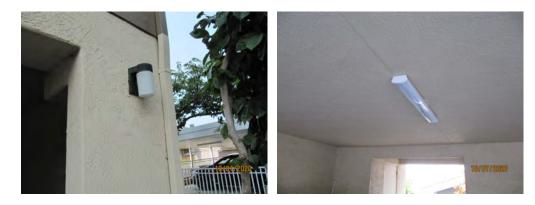
This component is an allowance for the repair, maintenance or replacement of the exterior carport lights.

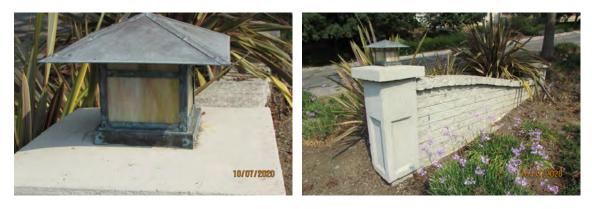
Lighting: Exterior-Entry-Replace		2 Each	@ \$317.68
Asset ID	1054	Asset Actual Cost	\$635.36
Group	Non-Capital	Percent Replacement	100%
Category	Lighting	Future Cost	\$706.48
Placed in Service	January 1999		
Useful Life	25		
Replacement Year	2024		
Remaining Life	3

This component is the replacement of the exterior light fixtures on top of the entry wall pilasters.

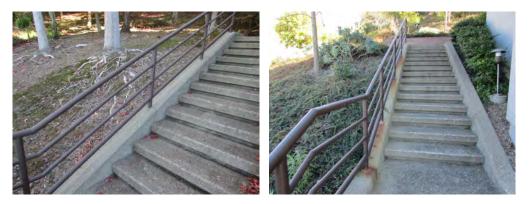
Railing: Metal-Replace		310 LF	@ \$83.39
Asset ID	1027	Asset Actual Cost	\$25,850.90
Group	Capital	Percent Replacement	100%
Category	Railings	Future Cost	\$36,819.10
Placed in Service	January 2001		
Useful Life	30		
Replacement Year	2031		
Remaining Life	10

THIS HAS BEEN UNFUNDED AND IS FOR INFORMATION ONLY. PER THE CC&R'S THE METAL RAILINGS ARE THE OWNER'S RESPONSIBILITY.

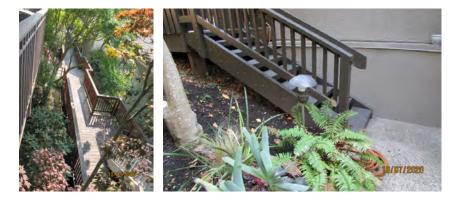
Railing: Wood-Replace		285 LF	@ \$26.92
Asset ID	1053	Asset Actual Cost	\$7,672.20
Group	Capital	Percent Replacement	100%
Category	Railings	Future Cost	\$7,948.40
Placed in Service	January 2002		
Useful Life	20		
Replacement Year	2022		
Remaining Life	1

THIS HAS BEEN UNFUNDED AND IS FOR INFORMATION ONLY. PER THE CC&R'S THE RAILINGS ARE THE OWNER'S RESPONSIBILITY.

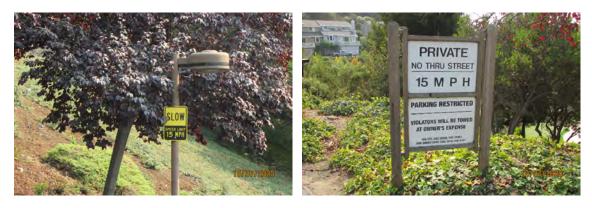
Signs: Wood, Painted,	Replace	1 Total	@ \$1,938.40
Asset ID	1016	Asset Actual Cost	\$1,938.40
Group	Capital	Percent Replacement	100%
Category	Signs	Future Cost	\$3,795.58
Placed in Service	January 2020		
Useful Life	20		
Replacement Year	2040		
Remaining Life	19

This component is the replacement of the common area signs. The sign at the entrance has been update to meet Oakland City Ordinance.

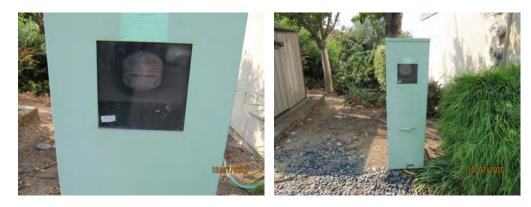
Utilities: Electrical-Replace		1 Total	@ \$135,052.73
Asset ID	1070	Asset Actual Cost	\$135,052.73
Group	Capital	Percent Replacement	100%
Category	Utilities	Future Cost	\$213,884.93
Placed in Service	August 1994		
Useful Life	40		
Replacement Year	2034		
Remaining Life	13

This component is the estimate for the replacement of the underground electrical utilities in the common area.

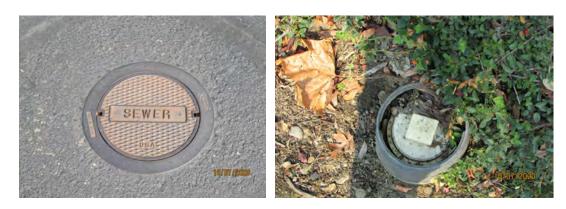
This component is the replacement or renovation of the waste product lines in the common area from the city main line to the property line of the owners. The work was performed by Advanced Trenchless.

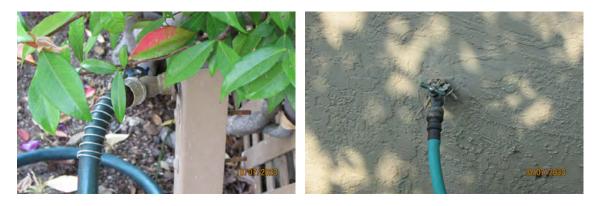
This component is the replacement or renovation of the potable water lines in the common area.

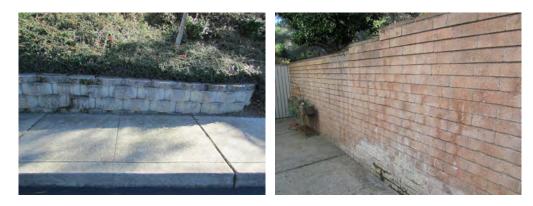
Walls: Retaining-Repairs	J	5,900 SF	@ \$38.25
Asset ID	1022	Asset Actual Cost	\$112,837.50
Group	Capital	Percent Replacement	50%
Category	Walls	Future Cost	\$112,837.50
Placed in Service	January 1967		
Useful Life	50		
Adjustment	4		
Replacement Year	2021		
Remaining Life	0

This component is an allowance of 50% for the cost of repair, maintenance or replacement of the block/brick retaining walls and entry walls. According to the CC&Rs, Exhibit B, Item 1, the Association is responsible for all retaining walls bordering decks or patios and the foundations of the retaining walls. Also, the retaining walls and their foundations which protect or support street-side decks.
