Hiller Highlands I Association

Spyglass Hill & Hiller Road
Oakland, California 94618
November 18, 2019

Executive Summary

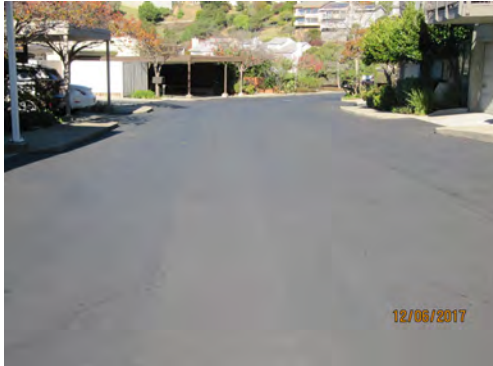
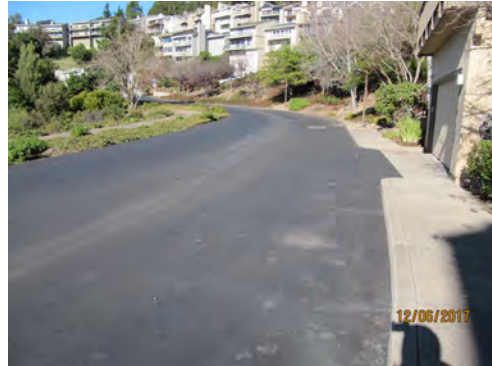
33,570 SF	@ \$1.95
Asset ID	1002	Asset Cost	\$65,461.50
Group	Capital	Percent Replacement	100%
Category	Asphalt	Future Cost	\$117,634.77
Placed in Service	September 2017		
Useful Life	25		
Replacement Year	2042		
Remaining Life	22

This component is the 2" to 3" overlay on the existing surface, including re-setting 27 manhole covers and 5 valve covers.

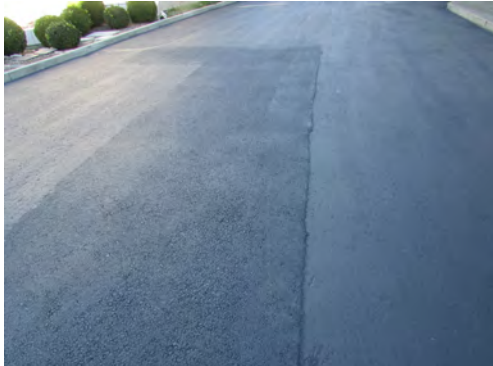
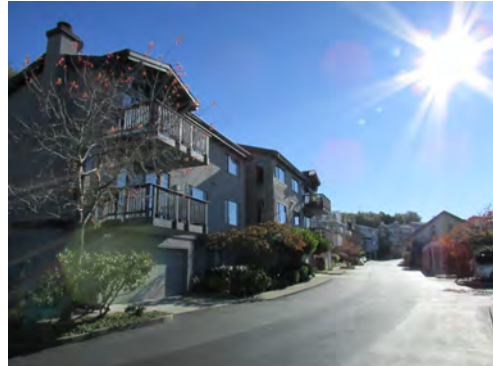
Asphalt: Repairs

33,570 SF	@ \$4.25
Asset ID	1003	Asset Cost	\$7,133.62
Group	Capital	Percent Replacement	5%
Category	Asphalt	Future Cost	\$7,524.04
Placed in Service	July 2017		
Useful Life	5		
Replacement Year	2022		
Remaining Life	2

This component is the repairs to the asphalt surface in conjunction with the application of sealcoat (5 years).

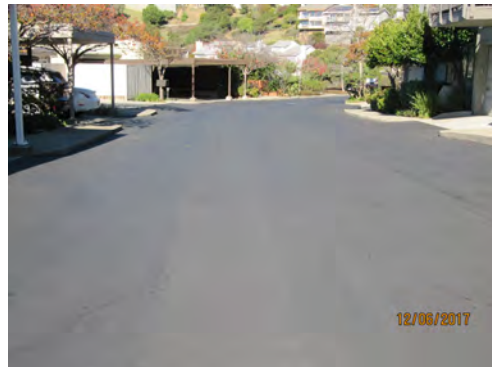
Asphalt: Seal Coat				
Asset ID	1036	33,570 SF	@ \$0.20	
Group	Non-Capital	Asset Cost	\$6,714.00	
Category	Asphalt	Percent Replacement	100%	
Placed in Service	September 2017	Future Cost	\$7,081.45	
Useful Life	5			
Replacement Year	2022			
Remaining Life	2

This component is the application of seal coating on the asphalt surface every 5 years in conjunction with repairs.

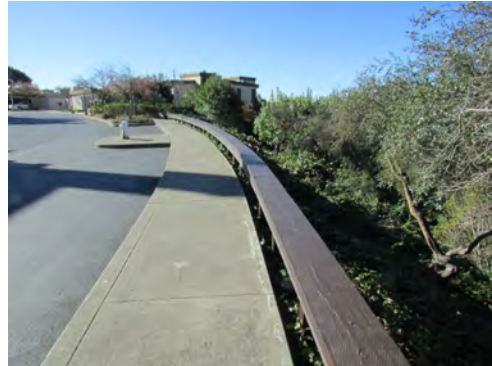
Asset ID	1065	1 Total	@ \$7,532.00
Group	Capital	Asset Cost	\$7,532.00
Category	Benches	Percent Replacement	100%
Placed in Service	October 2017	Future Cost	\$11,846.98
Useful Life	20		
Replacement Year	2037		
Remaining Life	17

This component is the replacement of the common area bench that runs along Spyglass Hill.

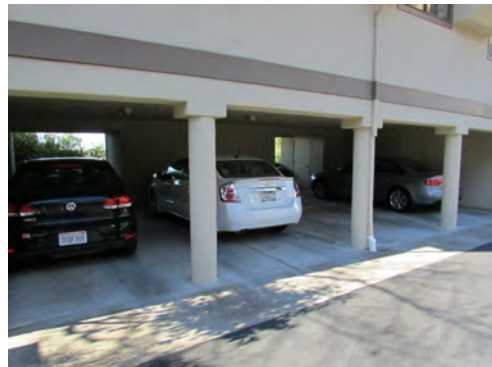
Asset ID	1061	1 Total	@ \$20,901.94
Group	Non-Capital	Asset Cost	\$20,901.94
Category	Concrete	Percent Replacement	100%
Placed in Service	January 2006	Future Cost	\$20,901.94
Useful Life	10		
Adjustment	4		
Replacement Year	2020		
Remaining Life	0

This component is the inspections of the crawlspace areas through the open carports and we suggest that the inspections should be done every 10 years.

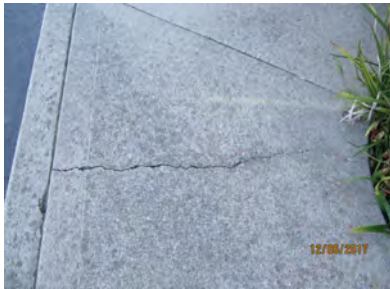
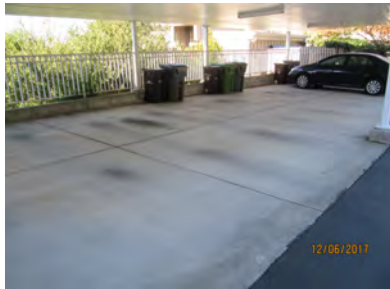
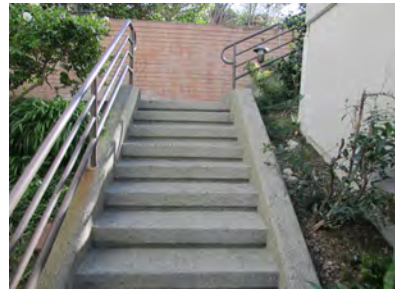
1 Total @ \$4,500.00
Asset ID	1013	Asset Cost	\$4,500.00
Group	Capital	Percent Replacement	100%
Category	Concrete	Future Cost	\$4,500.00
Placed in Service	January 2014		
Useful Life	5		
Adjustment	1		
Replacement Year	2020		
Remaining Life	0

This component is for the repair/partial replacement to the concrete stairs, pads, and flatwork. It is estimated that a percentage of the concrete areas will require repair or replacement. The actual condition of the concrete should be monitored through time and the estimates adjusted accordingly.

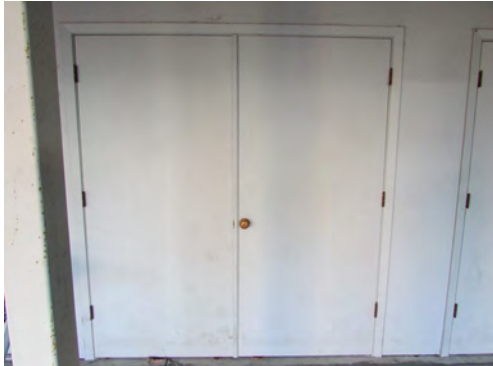
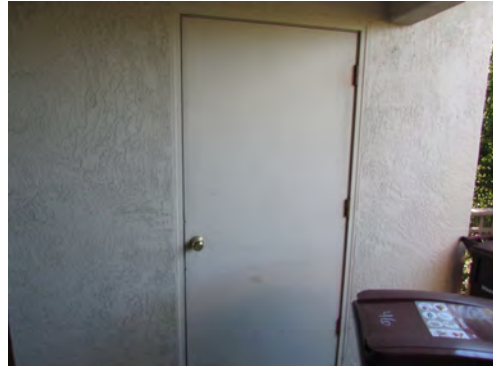
Doors: Storage-Replace

This component is the replacement of the storage doors in the open garages and carports.

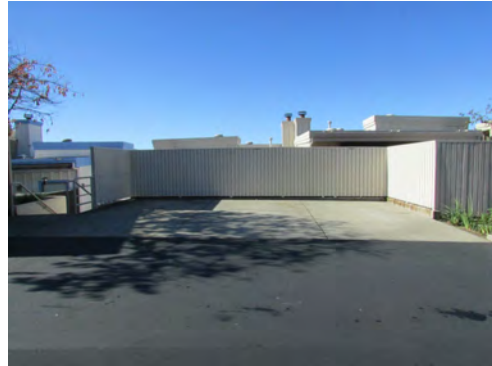
Fence: Wood-Replace

This component is the replacement of the wood fence in the parking area.

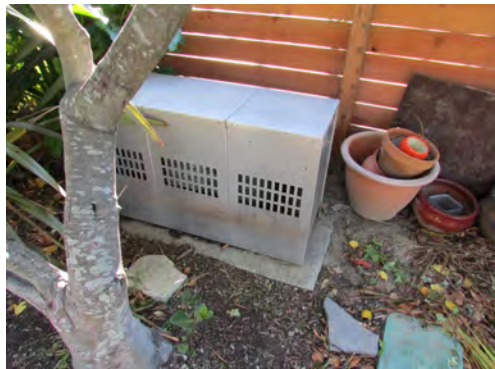
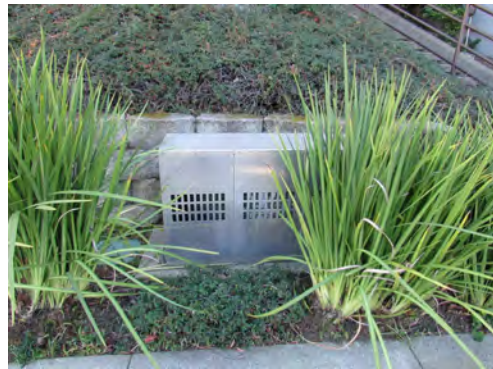
Landscape: Back Flow Preventor-Replace

This component is the replacement of the 2 common area, back flow preventors with insulation covers and box.

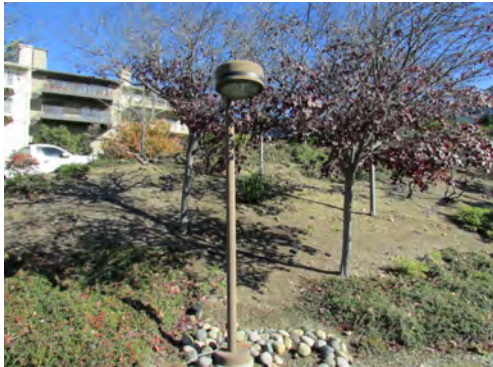
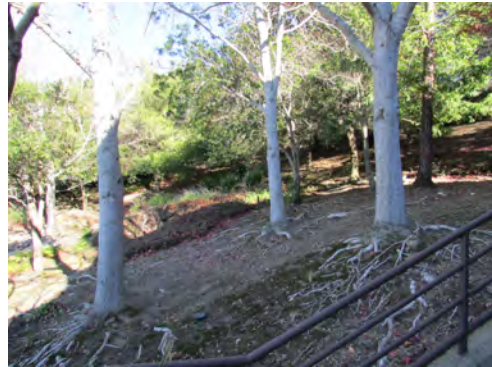
Landscape: Improvements-Fire Suppression

This component is the work required in the landscape area to aid in the suppression of fire.

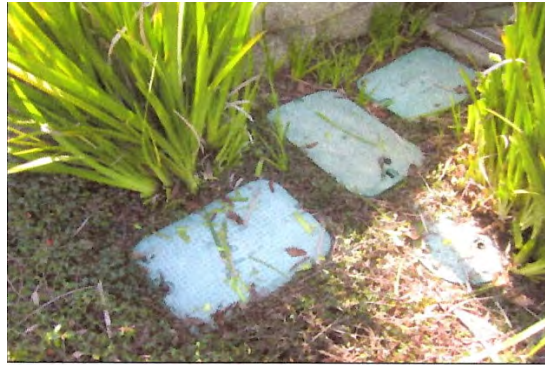
Landscape: Irrigation-Valves-Replace

This component is the replacement of the 72 landscape irrigation valves for the sprinkler system.

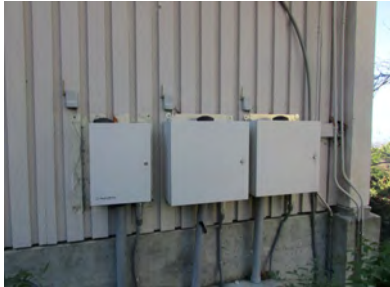
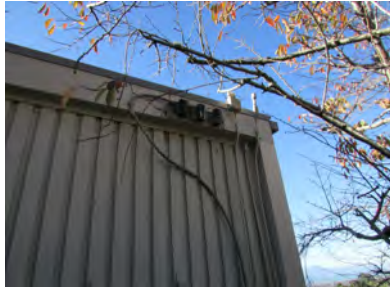
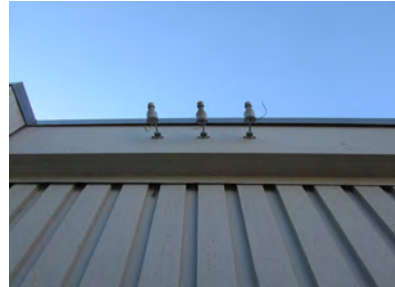
Landscape: Smart Controller System-A		1 Total	@ \$15,160.00
Asset ID	1038	Asset Cost	\$15,160.00
Group	Capital	Percent Replacement	100%
Category	Landscaping	Future Cost	\$27,242.62
Placed in Service	June 2017		
Useful Life	25		
Replacement Year	2042		
Remaining Life	22

This component is the replacement of the Smart Controller System for the landscape. This system consists of a weather center that is designed to operate with the controllers and provides "real-time" onsite data and rain switch. The controllers installed are:

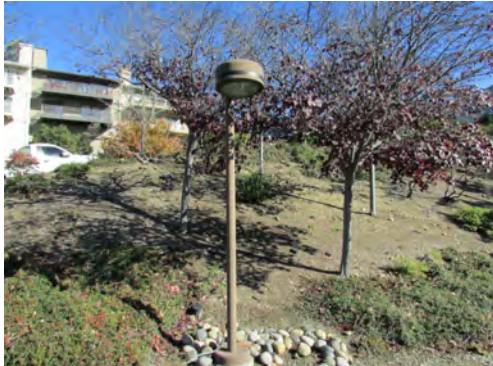
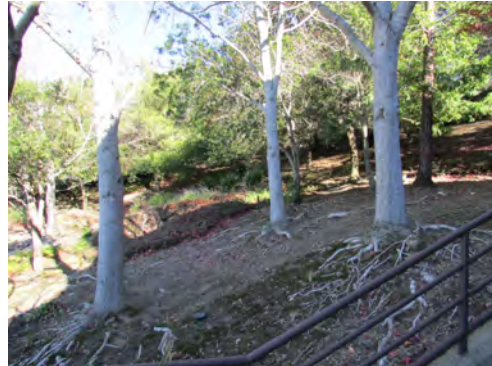
Landscape: Tree Renovation

This component is the work required on tree renovation as needed.

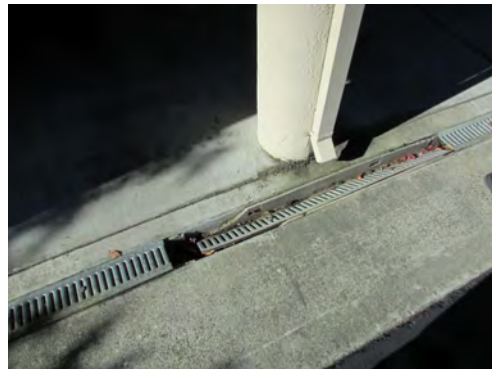
Lateral Drain: Replace/Repairs

This component is an allowance for the repair, maintenance or replacement of the lateral drains in the common area.

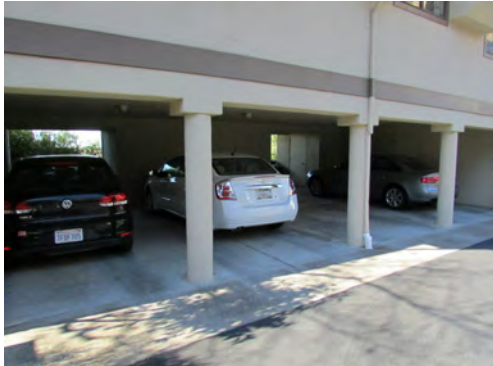
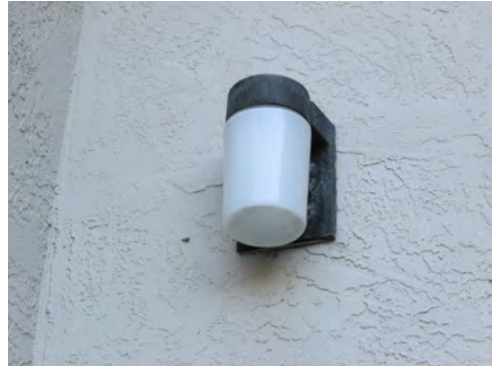
Lighting: Exterior-Carports-Repair/Replace

This component is an allowance for the repair, maintenance or replacement of the exterior carport lights.

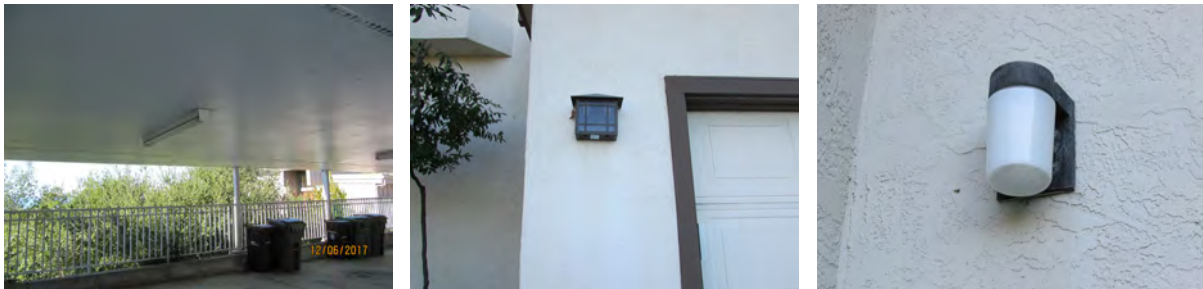
Lighting: Exterior-Entry Walls-Replace		26 Each	@ \$225.00
Asset ID	1021	Asset Cost	\$585.00
Group	Non-Capital	Percent Replacement	10%
Category	Lighting	Future Cost	\$650.78
Placed in Service	January 1999		
Useful Life	5		
Adjustment	20		
Replacement Year	2024		
Remaining Life	4

This component is an allowance for the replacement of the exterior light fixtures on the garages and carports.

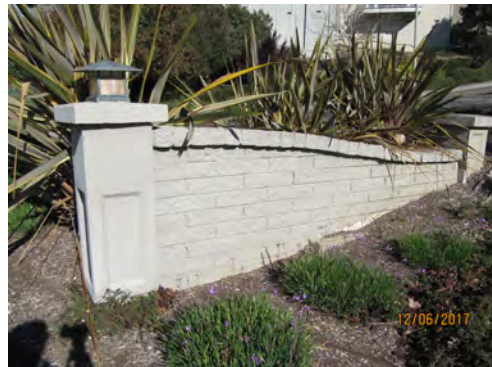
Lighting: Exterior-Entry-Replace

This component is the replacement of the exterior light fixtures top of the entry wall pilasters.

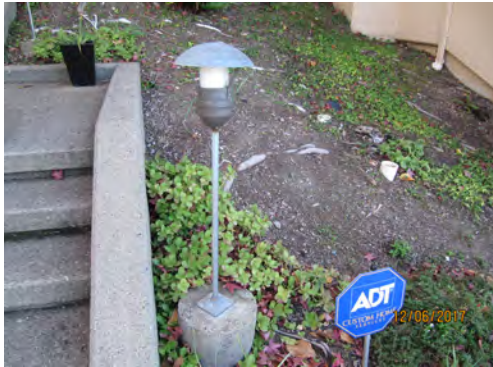
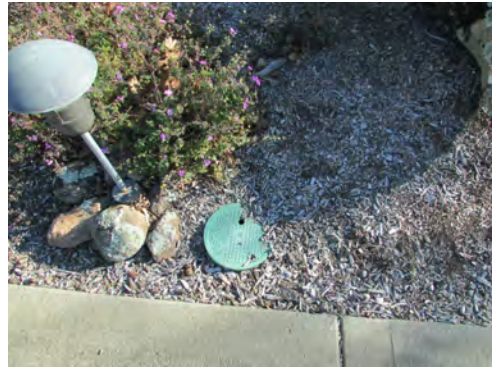
Lighting: Exterior-Landscape-Repair/Replace

This component is an allowance for the repair, maintenance or replacement of the landscape, path and sidewalk lights in the common area.

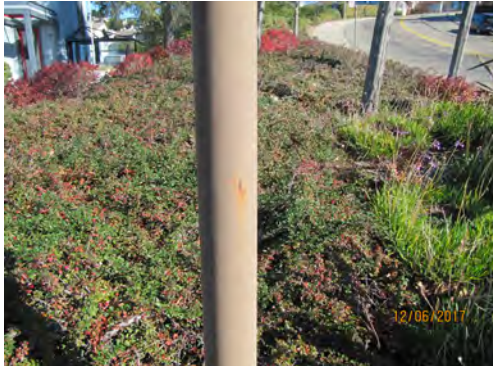
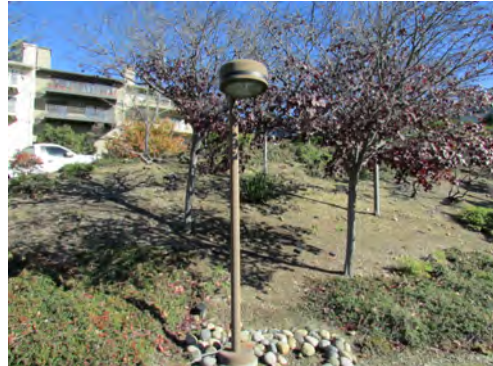
Lighting: Exterior-Street Light Poles

This component is the replacement of the street light poles, excluding the fixtures.

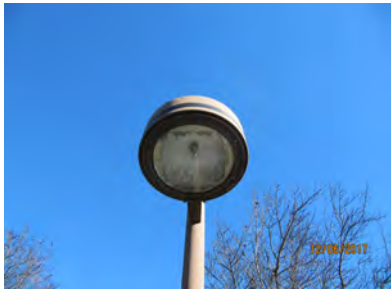
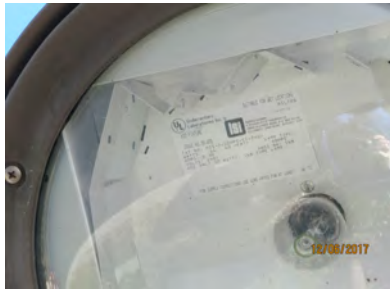
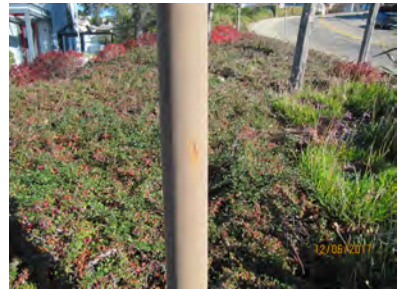
Lighting: Fixtures-Street Light Repair/Replace

This component is an allowance for the repair, maintenance or replacement of the HID street light fixtures, excluding the poles.

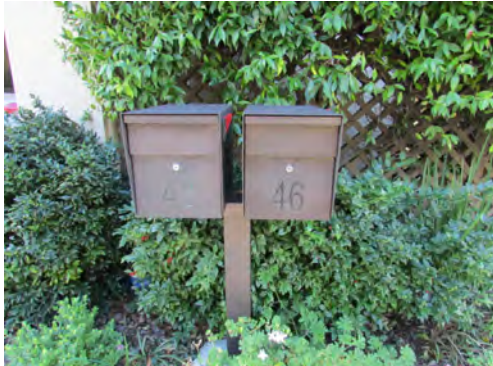
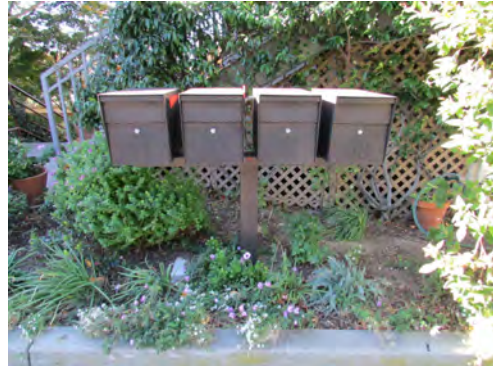
Mailboxes: Replace

This component is the replacement of the mail boxes for various lots. The wood kiosks have been removed.

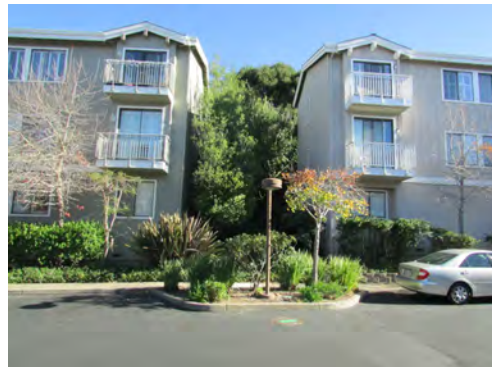
Paint: Exterior-Stucco-Bldgs E1/E2		7,630 sq. ft.	@ \$1.80
Asset ID		Asset Cost	\$1,373.40
		Percent Replacement	10%
Category	Painting	Future Cost	\$1,373.40
Placed in Service	January 1999		
Useful Life	10		
Adjustment	11		
Replacement Year	2020		
Remaining Life	0

The client's CC&Rs state that the association is responsible for 10% of the total cost for painting the exterior stucco of these buildings. We have budgeted accordingly.

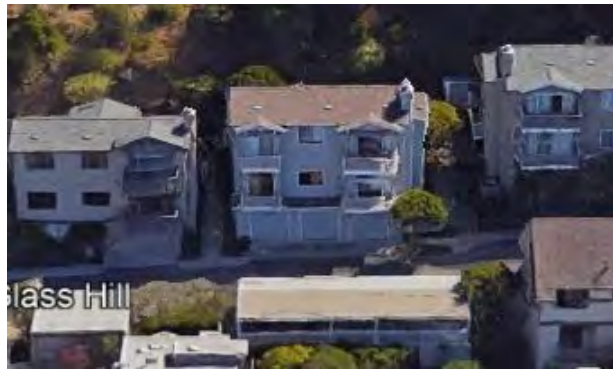
Paint: Exterior-Units 33 & 35-Bldg E1

This component is an estimate for the Association's share of the painting of the stucco exterior. According to the CC&Rs, the Association is responsible for 10% of the cost to paint the stucco. Photo credit to Google Earth.

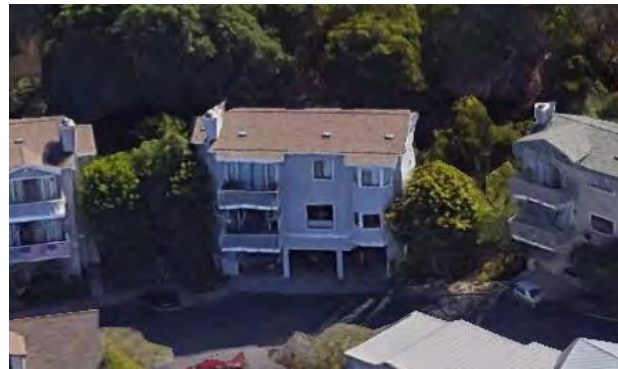
Paint: Exterior-Units 51 & 53-Bldg E2

This component is an estimate for the Association's share of the painting of the stucco exterior. According to the CC&Rs, the Association is responsible for 10% of the cost to paint the stucco. Photo credit to Google Earth.

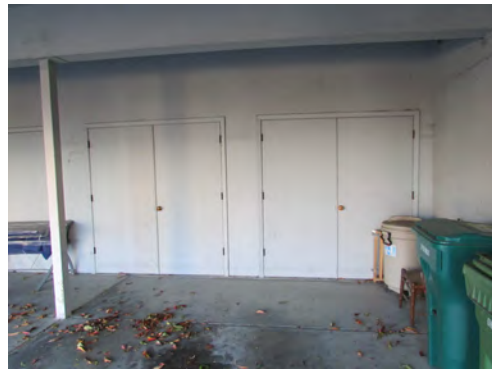
Paint: Interior-Garages-Bldgs C1-Unit 42		4,280 SF	@ \$1.60
Asset ID	1024	Asset Cost	\$2,935.05
Group	Non-Capital	Percent Replacement	42.86%
Category	Painting	Future Cost	\$2,935.05
Placed in Service	January 1999		
Useful Life	10		
Adjustment	11		
Replacement Year	2020		
Remaining Life	0

This component is the painting of the interior of the open garages/carport. According to the CC&Rs, the Association is responsible for 42.86% of the painting cost.

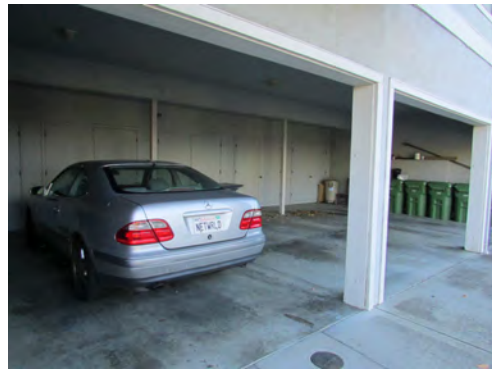
Paint: Interior-Garages-Bldgs C2-Unit 48		4,280 SF	@ \$1.60
Asset ID	1064	Asset Cost	\$2,935.05
Group	Non-Capital	Percent Replacement	42.86%
Category	Painting	Future Cost	\$2,935.05
Placed in Service	January 1999		
Useful Life	10		
Adjustment	11		
Replacement Year	2020		
Remaining Life	0

This component is the painting of the interior of the open garages/carport. According to the CC&Rs, the Association is responsible for 42.86% of the painting cost.

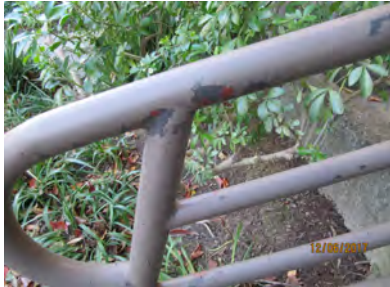
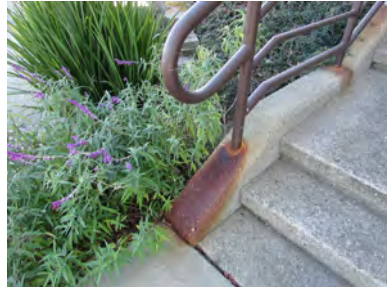
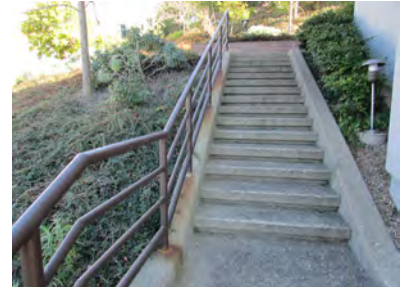
Paint: Metal Railings

This component is the painting of the metal stairway railings and hand railings.

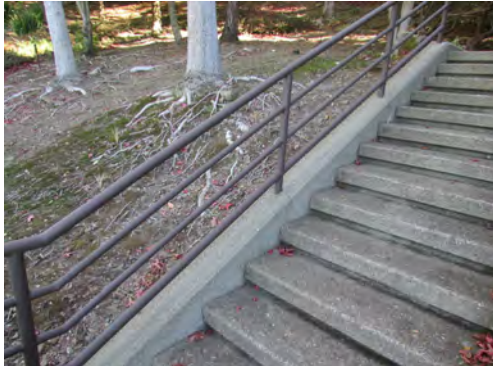
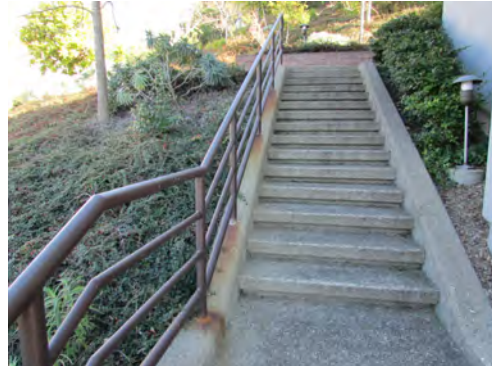
Railing: Metal-Replace

This component is the replacement of the metal railings in the common area.

This component was in fair condition at the time of the physical analysis.

Rust was noted at the base of the railing at the time of the physical analysis.

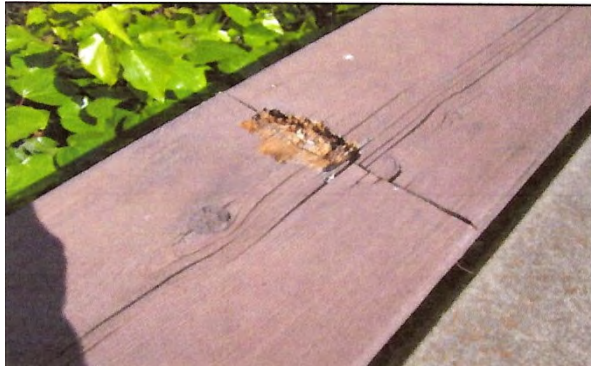
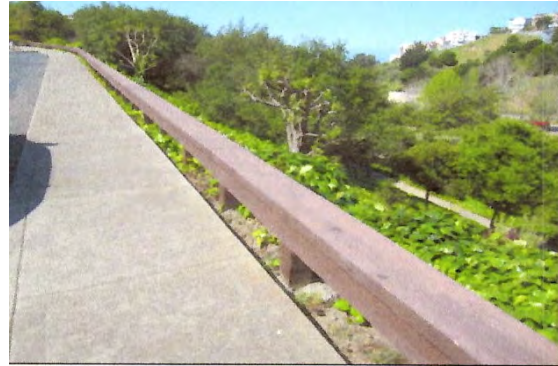
Railing: Wood-Replace

This component is the replacement of the wood railings by the sidewalks, deck and bench.

Some dry rot and paint peeling was noted during the on-site physical analysis in 2015.

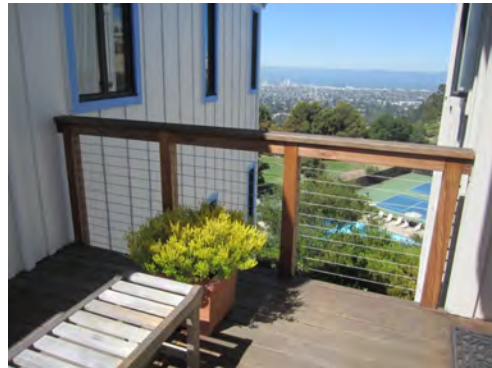
Seal: Wood, Decks/Walkways, Bldgs D1/D2

During our 2009 field inspection, it was noted these decks/walkways, stairways, and railings appeared to need sealing.

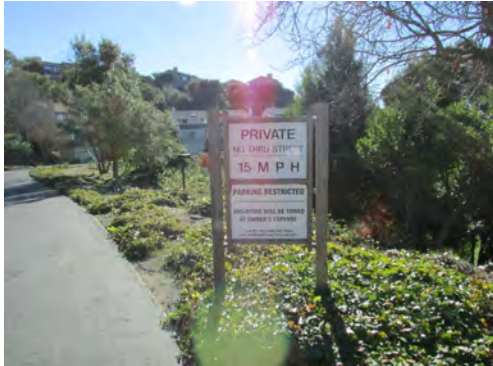
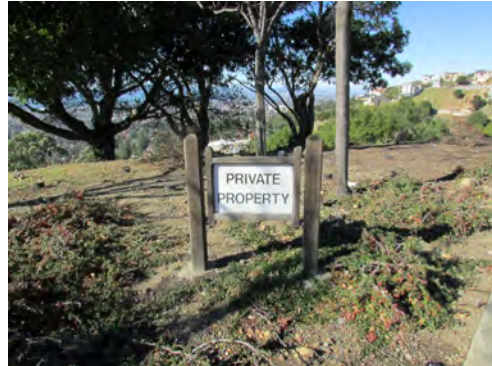
Asset ID	1016	1 Total	@ \$1,800.00
Group	Capital	Asset Cost	\$1,800.00
Category	Signs	Percent Replacement	100%
Placed in Service	January 2001	Future Cost	\$1,848.60
Useful Life	20		
Replacement Year	2021		
Remaining Life	1

This component is the replacement of the common area signs.

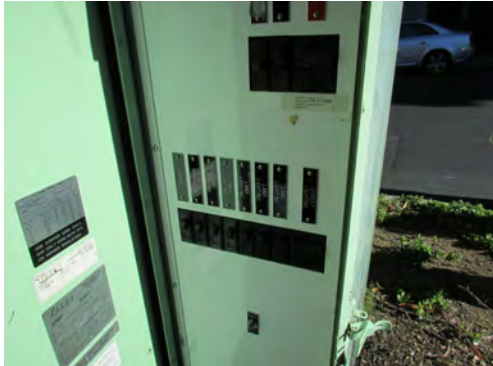
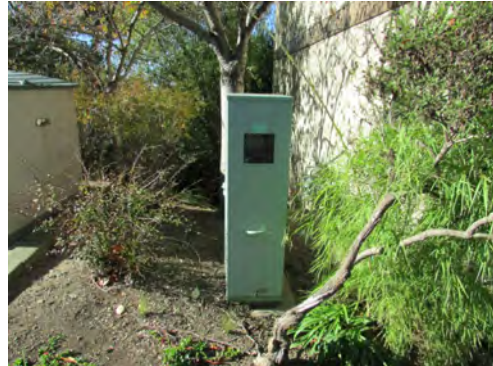
Utilities: Electrical-Replace

This component is the estimate for the replacement of the underground electrical utilities in the common area.

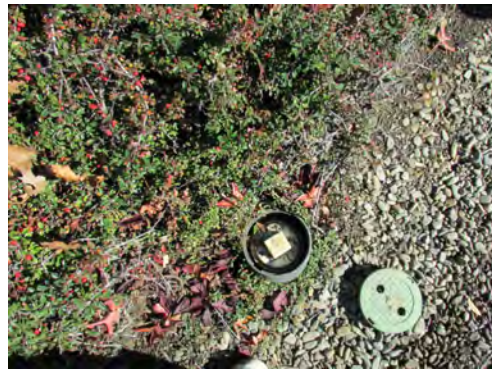
Utilities: Waste Product-Line-Replacement

This component is the replacement or renovation of the waste product lines in the common area from the city main line to the property line of the owners. The work was performed by Advanced Trenchless.

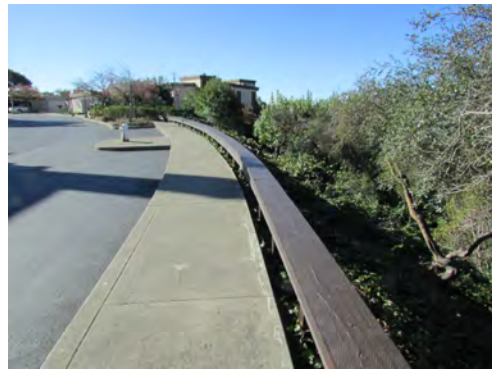
Wall/Bench: Wood, Spyglass Hill-Replace

During our August 2012 field inspection, it was noted this wall/bench appeared to need painting or staining.

This wood wall/bench is located along Spyglass Hill. It is 1.5' H. It appears to be sealed or stained, and has a plaque mounted to it near the stairs leading to the clubhouse area.

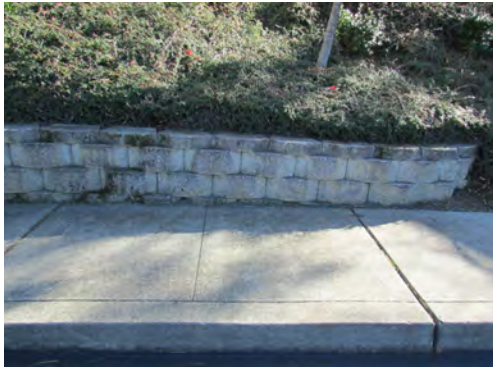
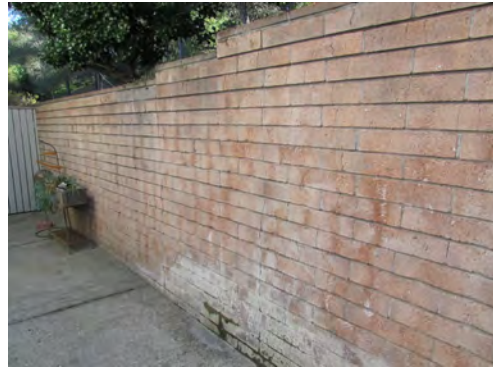
Walls: Block-Retaining-Repairs

This component is an allowance for the cost of repair, maintenance or replacement of the block retaining walls and entry walls. According to the CC&Rs, Exhibit B, Item 1, the Association is responsible for all retaining walls bordering decks or patios and the foundations of the retaining walls. Also, the retaining walls and their foundations which protect or support street-side decks.

During the August 2012 field inspection the client advised the HOA consulted an engineer on the condition of the wall. The engineer advised the wall will need repairs however no definite timeline could be given. The client identified a portion of the wall with visible cracking and water penetrating the wall and the client advised the HOA does not have plans to repair the wall in the near future. This asset should be monitored and the repairs schedule should be adjusted when necessary (2012 comment).

During our 2009 field inspection, it was noted these walls appeared to need cleaning and repairs.

We are budgeting 10% of the total cost for replacement of these retaining block walls, as repairs every 25 years.

It is estimated that a percentage of the block walls will require repair or replacement. The actual condition of the block walls should be monitored through time and the estimates adjusted accordingly.

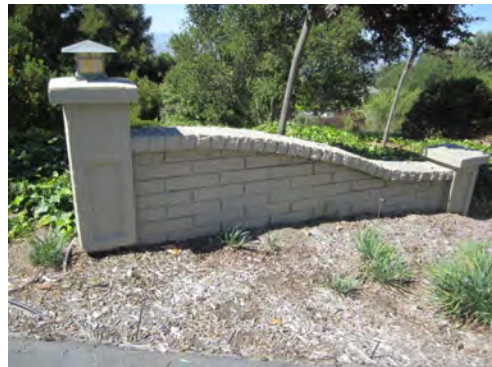
Walls: Stucco-Repairs

The useful life of this asset has been extended due to its present condition.

We are budgeting 10% of the total cost for replacement of these stucco walls, as repairs every 15 years, beginning during the 2012 fiscal year (2009 comment).

It is estimated that a percentage of the stucco walls will require repair or replacement. The actual condition of the stucco walls should be monitored through time and the estimates adjusted accordingly.
