Hiller Highlands I Association

Spyglass Hill & Hiller Road
Oakland, California 94618
October 30, 2021

Fiscal Year 2022 Version 1

Executive Summary

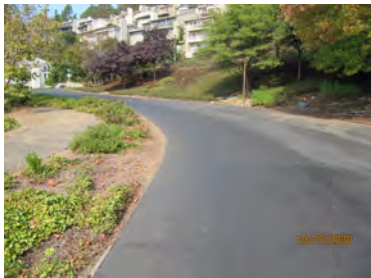
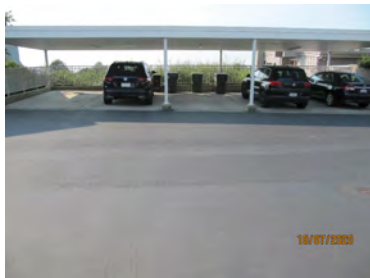
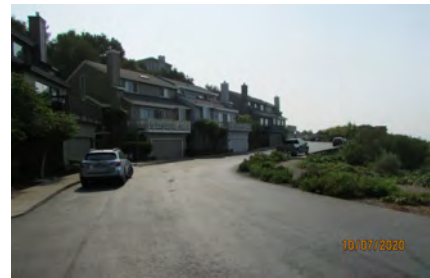
33,570 SF	@ \$6.14
Asset ID	1002	Asset Actual Cost	\$206,119.80
Group	Capital	Percent Replacement	100%
Category	Asphalt	Future Cost	\$282,089.18
Placed in Service	September 2017		
Useful Life	25		
Adjustment	-12		
Replacement Year	2030		
Remaining Life	8

This component is the 2" to 3" overlay on the existing surface, including re-setting 27 manhole covers and 5 valve covers.

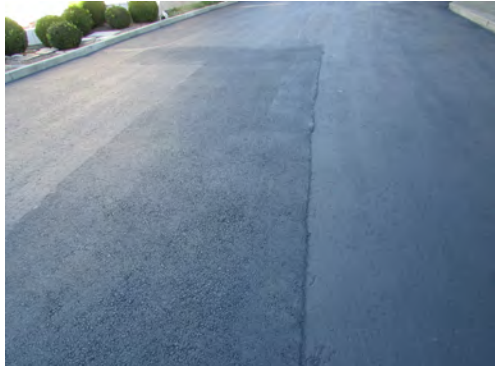
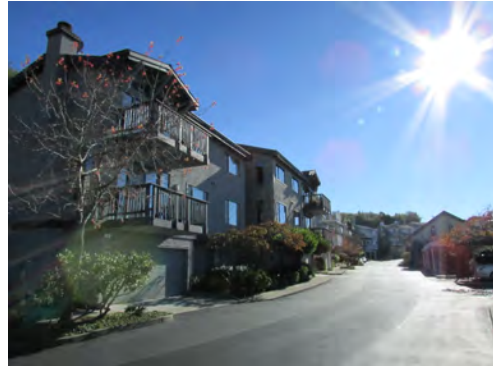
Asphalt: Repairs

33,570 SF	@ \$6.92
Asset ID	1003	Asset Actual Cost	\$11,615.22
Group	Capital	Percent Replacement	5%
Category	Asphalt	Future Cost	\$11,615.22
Placed in Service	July 2017		
Useful Life	5		
Replacement Year	2022		
Remaining Life	0

This component is the repairs to the asphalt surface in conjunction with the application of sealcoat (5 years).

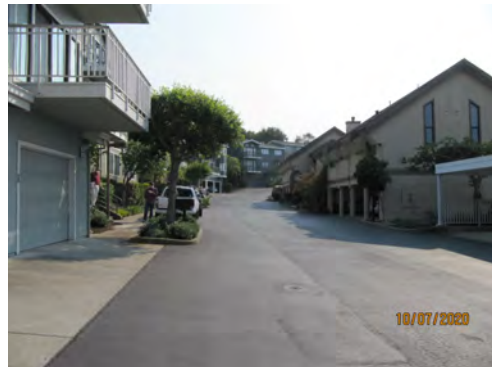
Asphalt: Seal Coat		33,570 SF	@ \$0.71
Asset ID	1036	Asset Actual Cost	\$23,834.70
Group	Non-Capital	Percent Replacement	100%
Category	Asphalt	Future Cost	\$23,834.70
Placed in Service	September 2017		
Useful Life	5		
Replacement Year	2022		
Remaining Life	0

This component is the application of seal coating on the asphalt surface every 5 years in conjunction with repairs.

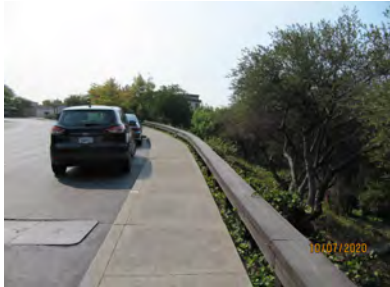
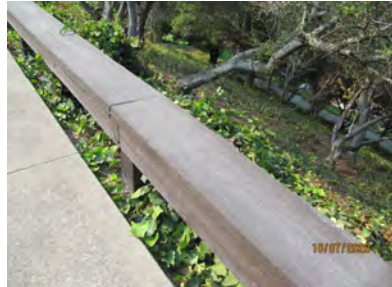
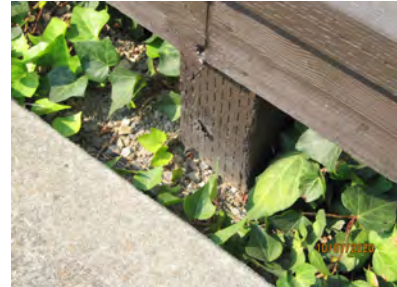
1 Total	@ \$8,354.47
Asset ID	1065	Asset Actual Cost	\$8,354.47
Group	Capital	Percent Replacement	100%
Category	Benches	Future Cost	\$15,045.93
Placed in Service	October 2017		
Useful Life	20		
Replacement Year	2037		
Remaining Life	15

This component is the replacement of the common area bench that runs along Spyglass Hill.

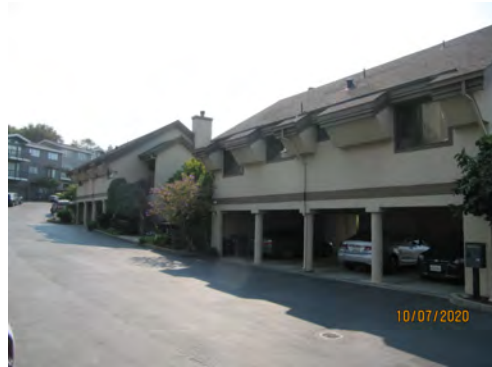
1 Total	@ \$20,600.00
Asset ID	1061	Asset Actual Cost	\$20,600.00
Group	Non-Capital	Percent Replacement	100%
Category	Concrete	Future Cost	\$20,600.00
Placed in Service	January 2006		
Useful Life	10		
Adjustment	5		
Replacement Year	2022		
Remaining Life	0

This component is the inspections of the crawlspace areas through the open carports and we suggest that the inspections should be done every 10 years.

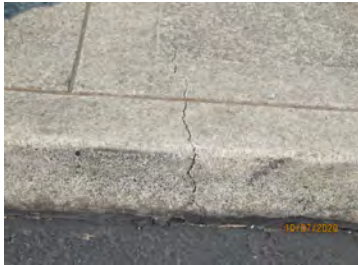
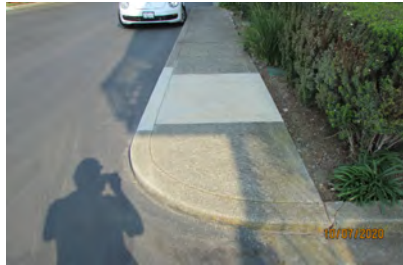
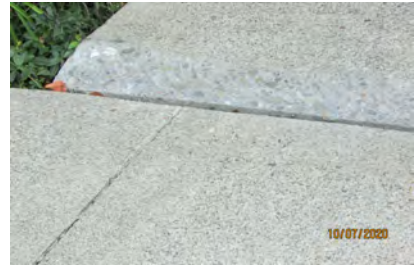
1 Total	@ \$5,150.00
Asset ID	1013	Asset Actual Cost	\$5,150.00
Group	Capital	Percent Replacement	100%
Category	Concrete	Future Cost	\$5,793.05
Placed in Service	October 2020		
Useful Life	5		
Replacement Year	2025		
Remaining Life	3

This component is for the repair/partial replacement to the concrete stairs, pads, and flatwork. It is estimated that a percentage of the concrete areas will require repair or replacement. The actual condition of the concrete should be monitored through time and the estimates adjusted accordingly.

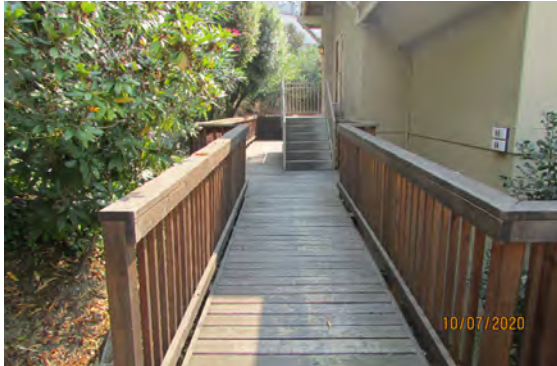
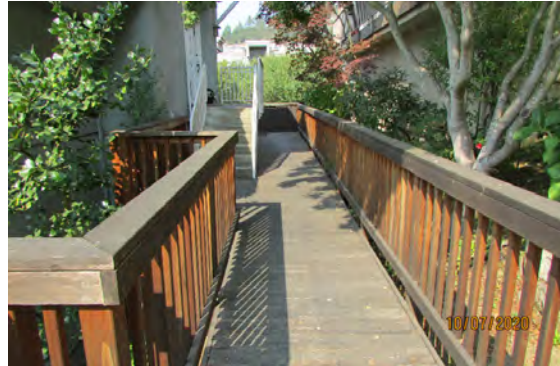
1,786 SF	@ \$19.22
Asset ID	1028	Asset Actual Cost	\$34,326.92
Group	Capital	Percent Replacement	100%
Category	Decks	Future Cost	\$61,820.84
Placed in Service	October 2017		
Useful Life	20		
Replacement Year	2037		
Remaining Life	15

This component is the replacement of the wood deck, railings and stairs located in front of the upper units of buildings D1 and D2.

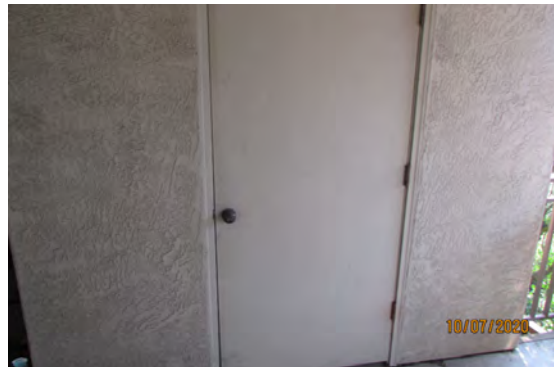
Doors: Storage-Replace

32 Each	@ \$1,060.61
Asset ID	1031	Asset Actual Cost	\$33,939.52
Group	Capital	Percent Replacement	100%
Category	Doors	Future Cost	\$58,772.27
Placed in Service	January 2006		
Useful Life	30		
Replacement Year	2036		
Remaining Life	14

This component is the replacement of the storage doors in the open garages and carports.

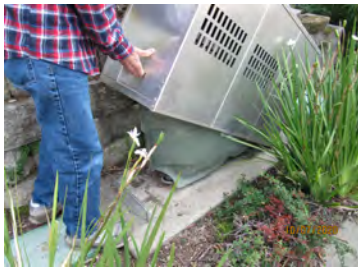
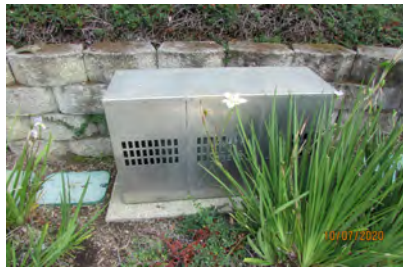
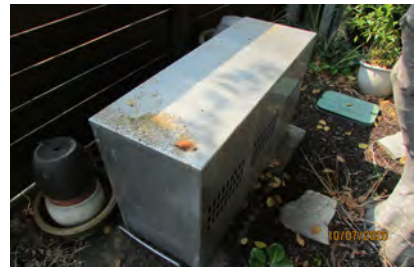
2 Each	@ \$7,089.54
Asset ID	1049	Asset Actual Cost	\$14,179.08
Group	Capital	Percent Replacement	100%
Category	Landscaping	Future Cost	\$15,336.09
Placed in Service	January 1994		
Useful Life	30		
Replacement Year	2024		
Remaining Life	2

This component is the replacement of the 2 common area, back flow preventors with insulation covers and box.

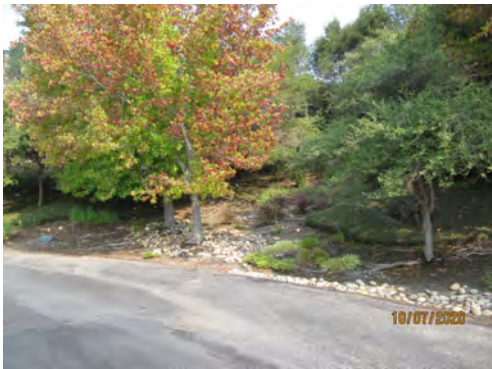
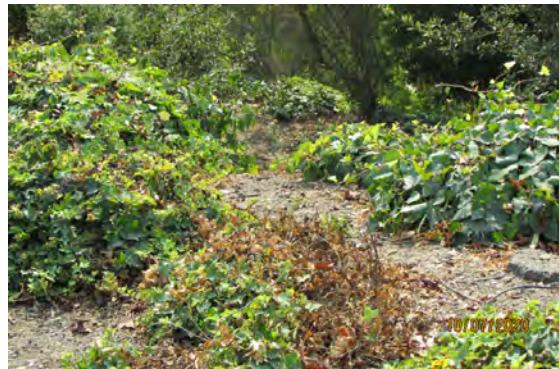
1 Total	@ \$10,300.00
Asset ID	1060	Asset Actual Cost	\$10,300.00
Group	Capital	Percent Replacement	100%
Category	Landscaping	Future Cost	\$10,712.00
Placed in Service	July 2017		
Useful Life	6		
Replacement Year	2023		
Remaining Life	1

This component is the work required in the landscape area to aid in the suppression of fire.

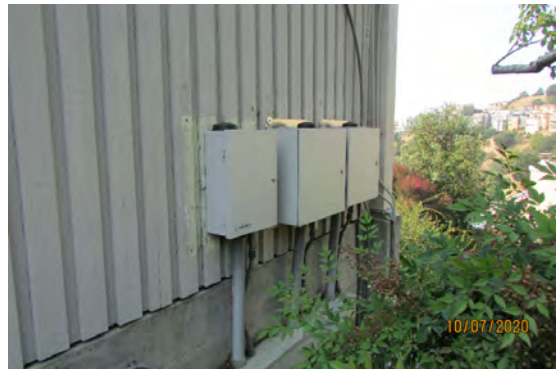
1 Total	@ \$16,815.43
Asset ID	1038	Asset Actual Cost	\$16,815.43
Group	Capital	Percent Replacement	100%
Category	Landscaping	Future Cost	\$36,844.68
Placed in Service	June 2017		
Useful Life	25		
Replacement Year	2042		
Remaining Life	20

This component is the replacement of the Smart Controller System for the landscape. This system consists of a weather center that is designed to operate with the controllers and provides "real-time" onsite data and rain switch. The controllers installed are:

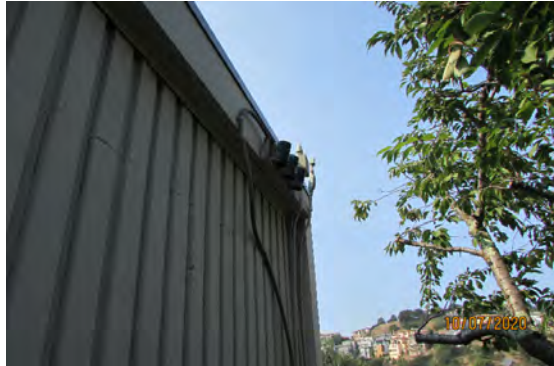
Landscape: Smart Controller System-B		2 Each	@ \$4,081.56
Asset ID	1072	Asset Actual Cost	\$8,163.12
Group	Capital	Percent Replacement	100%
Category	Landscaping	Future Cost	\$18,601.86
Placed in Service	June 2018		
Useful Life	25		
Replacement Year	2043		
Remaining Life	21

This component is the replacement of two of the Smart Controllers for the landscape. This system consists of a weather center that is designed to operate with the controllers and provides "real-time" onsite data and rain switch.

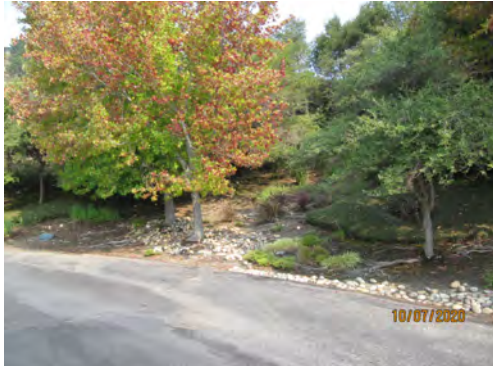
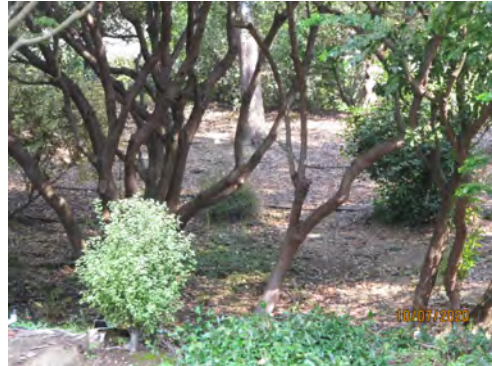
1 Total	@ \$10,300.00
Asset ID	1074	Asset Actual Cost	\$10,300.00
Group	Capital	Percent Replacement	100%
Category	Landscaping	Future Cost	\$13,554.10
Placed in Service	July 2019		
Useful Life	10		
Replacement Year	2029		
Remaining Life	7

This component is the work required on tree renovation as needed.

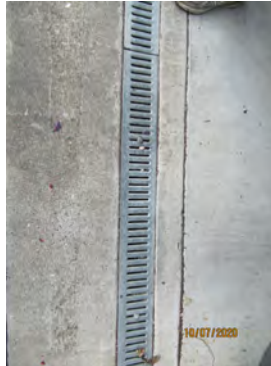
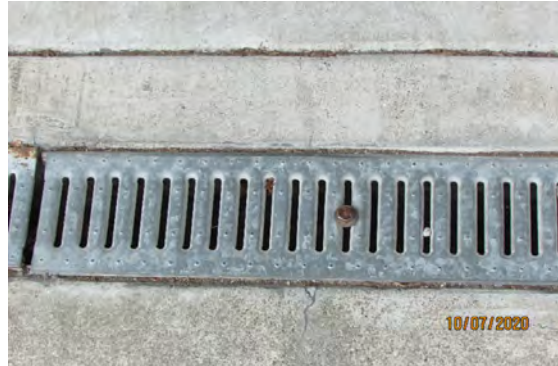
1 Total	@ \$14,490.24
Asset ID	1040	Asset Actual Cost		\$1,449.02
Group	Capital	Percent Replacement		10%
Category	Grounds Components	Future Cost		\$1,567.26
Placed in Service	October 2019			
Useful Life	5			
Replacement Year	2024			
Remaining Life	2

This component is an allowance for the repair, maintenance or replacement of the lateral drains in the common area.

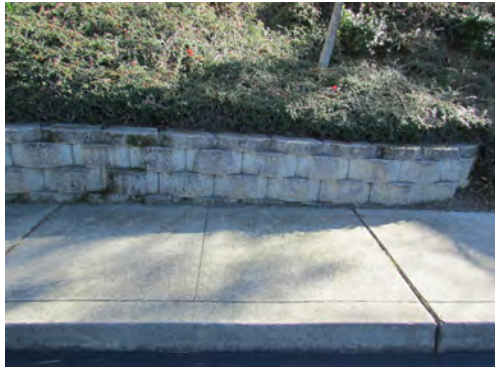
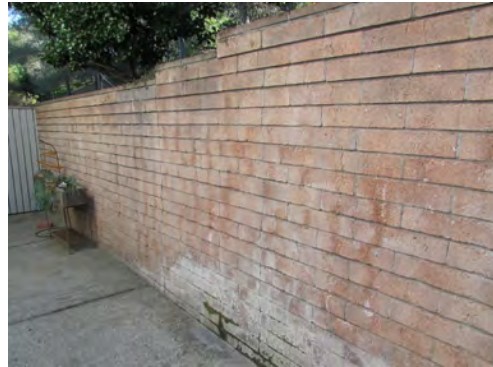
5,900 SF	@ \$39.40
Asset ID	1022	Asset Actual Cost	\$116,230.00
Group	Capital	Percent Replacement	50%
Category	Walls	Future Cost	\$116,230.00
Placed in Service	January 1967		
Useful Life	50		
Adjustment	4		
Replacement Year	2022		
Remaining Life	0
